**RAILWAY INVESTIGATION REPORT**  
**R00T0067**

**MAIN TRACK TRAIN DERAILMENT**

**ONTARIO NORTHLAND RAILWAY**  
**FREIGHT TRAIN NO. 402**  
**MILE 63.4, TEMAGAMI SUBDIVISION**  
**TEMAGAMI, ONTARIO**  
**14 MARCH 2000**

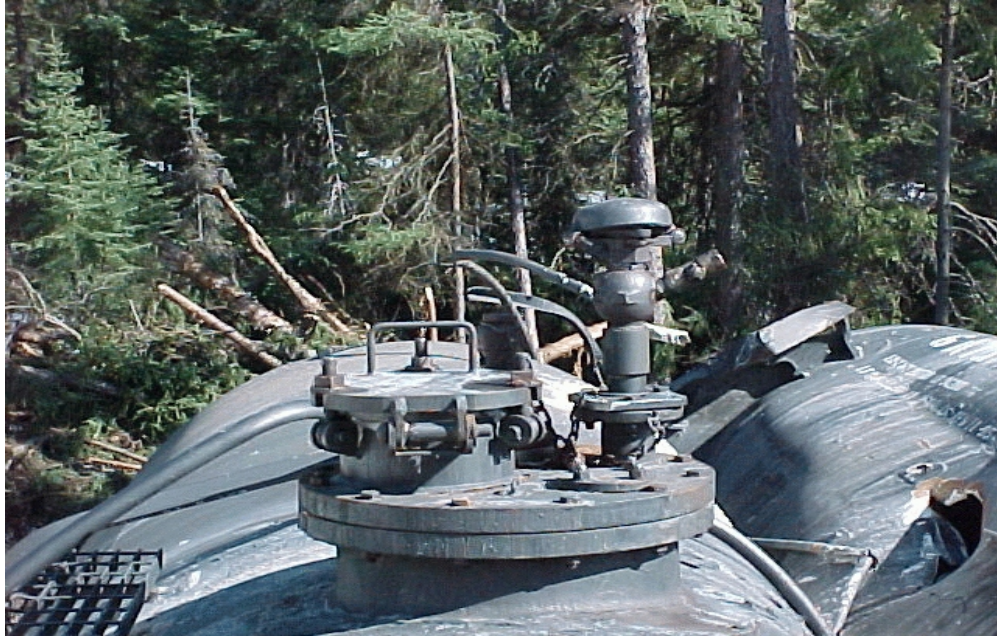
Figure 3 - A typical top fitting arrangement on a specification 111 tank car

In order to transport sulphuric acid, purpose-built tank cars are used because of the high density of the product. A typical tank car for sulphuric acid service is about 45 feet long, with an empty weight of about 27 tons. The volume of the tank is typically about 50 000 litres which translates into a fully loaded weight of about 130 tons. Specification 111 tank cars for transportation of sulphuric acid are not permitted to have bottom outlet valves unless they are being transported as a unit train which consists of cars of sulphuric acid only. Cars with bottom unloading valves are equipped with skid plates to prevent shearing off in case of an accident. Alternatively, bottom outlet valves may be recessed into the tank. However, on tank cars such as those involved in this derailment, top fittings have no protection against shearing off in a rollover.

The typical arrangement of the upper part of a sulphuric acid tank car includes a fill hole which is usually about eight inches in diameter, a discharge outlet which is about two inches in diameter, an air connection and valve which is usually one inch in diameter and contains a rupture disc assembly. The rupture disc covers the opening in the safety vent. The safety vent is a device designed to relieve excess pressure from the inside of the tank but does not close after it is ruptured. Although many general service specification 111 tank cars have safety valves that close after excessive pressure is released, tank cars in sulphuric acid service have rupture discs instead. The use of rupture discs is preferable to safety valves where the assembly is exposed to corrosive products such as acid. A typical arrangement of the appurtenances on the top of a sulphuric acid tank car is depicted in Figure 3. It should be noted that there was no top fitting protection on any of the tank cars involved. Figure 4 shows the tank with top fittings sheared off. Tank cars leased by Noranda Inc. are equipped with hydro-damps to reduce the risk of rupture disc failure by reducing the sloshing of the liquid acid.
